**Flood Control Project Maintenance
Levee Inspections**
LMA District Cover Sheet
Spring 2009 Levee Inspection Results

Reclamation District No. 0563

Waterway			Bank	Unit Miles
Unit No. 01 Georgiana Slough (Tyler Island)			Left	12.40

Levee Inspection Report By Mile - Spring 2009

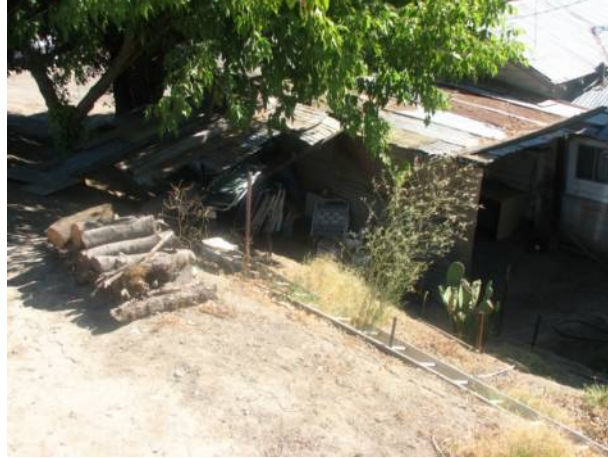
Levee Mile Report Line	14
Start Levee Mile	1.25
End Levee Mile	1.25
Location	Land Side
Category	Earthen Levee
Item	Encroachments

14	1.25	1.25	Earthen Levee	Encroachments	LS	PO	Buildings	38.226345 ° -121.532332 °	38.226345 ° -121.532332 °	Y	57
15	1.44	1.48	Earthen Levee	Vegetation	WS	M	Remove the wild growth other than native grasses from the levee slopes. Inspector Comments: Remove century plant from waterward shoulder.	38.224280 ° -121.534377 °	38.224000 ° -121.535038 °	Y	6
16	1.86	1.86	Earthen Levee	Encroachments	LS	PO	Stairways Inspector Comments: Retaining Wall at landside toe of levee. New stairs and flower box on landside slope.	38.222702 ° -121.541678 °	38.222702 ° -121.541678 °	Y	60

Looking at shed at landside toe.

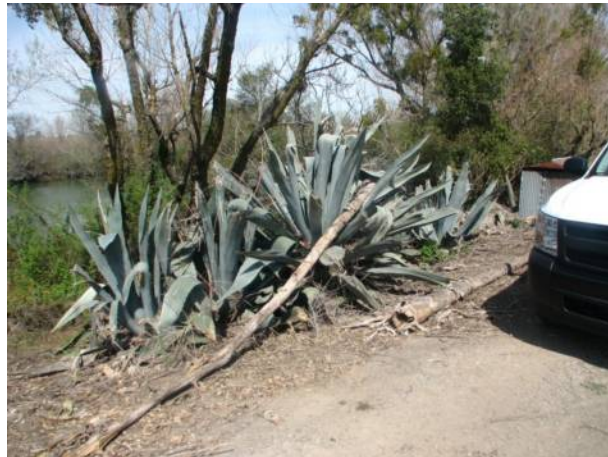
Levee Mile Report Line	15
Start Levee Mile	1.44
End Levee Mile	1.48
Location	Water Side
Category	Earthen Levee
Item	Vegetation

Century plant on waterward shoulder at LM 1.42

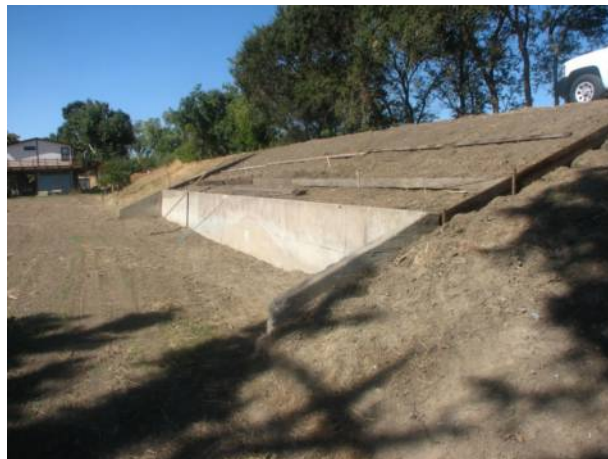
Levee Mile Report Line	16
Start Levee Mile	1.86
End Levee Mile	1.86
Location	Land Side
Category	Earthen Levee
Item	Encroachments

Unauthorized retaining wall on landside toe.

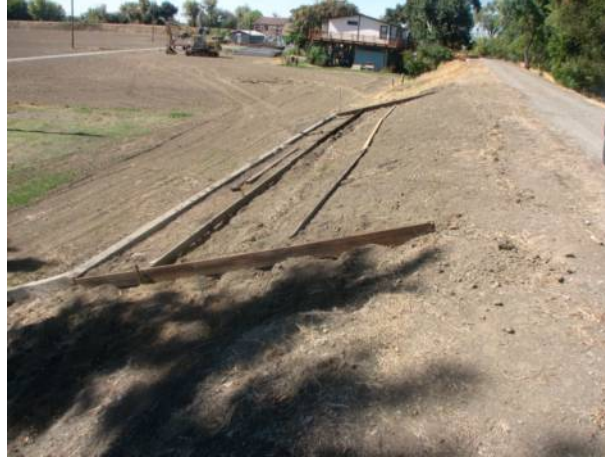
Levee Mile Report Line	16
Start Levee Mile	1.86
End Levee Mile	1.86
Location	Land Side
Category	Earthen Levee
Item	Encroachments

Flower box above retaining wall on landside slope

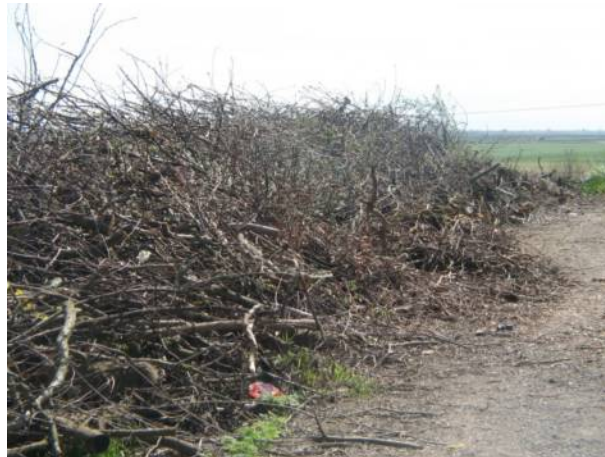
Levee Mile Report Line	26
Start Levee Mile	2.94
End Levee Mile	2.95
Location	Land Side
Category	Earthen Levee
Item	Encroachments

Prunings on landward shoulder from LM 2.93 to 2.95

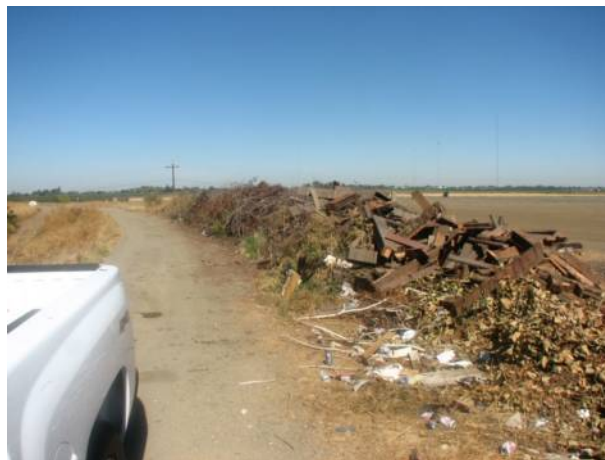
Levee Mile Report Line	26
Start Levee Mile	2.94
End Levee Mile	2.95
Location	Land Side
Category	Earthen Levee
Item	Encroachments

View looking upstream at pruning pile.

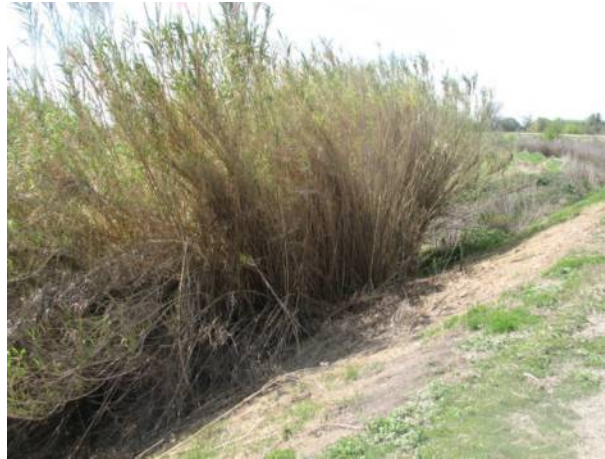
Levee Mile Report Line	27
Start Levee Mile	3.06
End Levee Mile	3.12
Location	Land Side
Category	Earthen Levee
Item	Vegetation

Bamboo at landward toe at LM 3.05

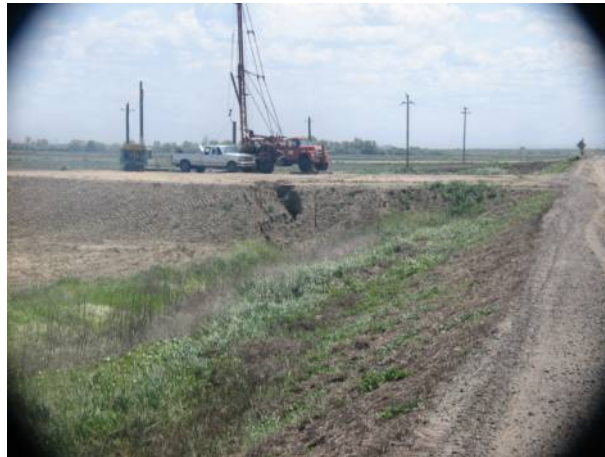
Levee Mile Report Line	31
Start Levee Mile	3.63
End Levee Mile	3.65
Location	Land Side
Category	Earthen Levee
Item	Encroachments

30	3.28	3.34	Earthen Levee	Trim / Thin Trees	LS	M	Trim trees to at least five feet above ground level.	38.209293 ° -121.539787 °	38.208515 ° -121.540412 °		19
31	3.63	3.65	Earthen Levee	Encroachments	LS	PO	Buildings Inspector Comments: Landowner building house pad for new home 100'x 100'	38.204600 ° -121.540232 °	38.204300 ° -121.540133 °	Y	940

Looking upstream at building pad at landside slope. Pad is approx. 100' x 100'

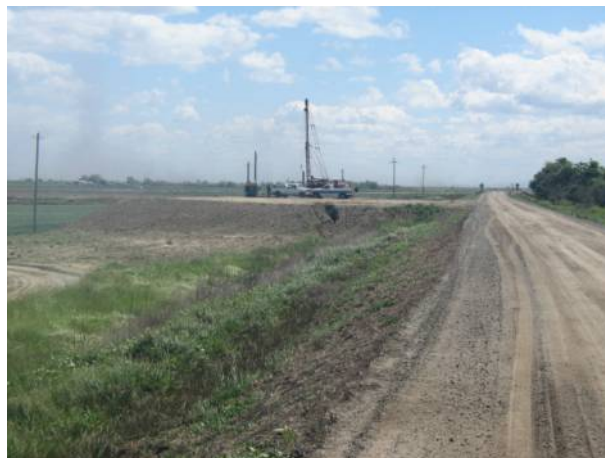
Levee Mile Report Line	31
Start Levee Mile	3.63
End Levee Mile	3.65
Location	Land Side
Category	Earthen Levee
Item	Encroachments

Looking upstream at house pad on landside slope.

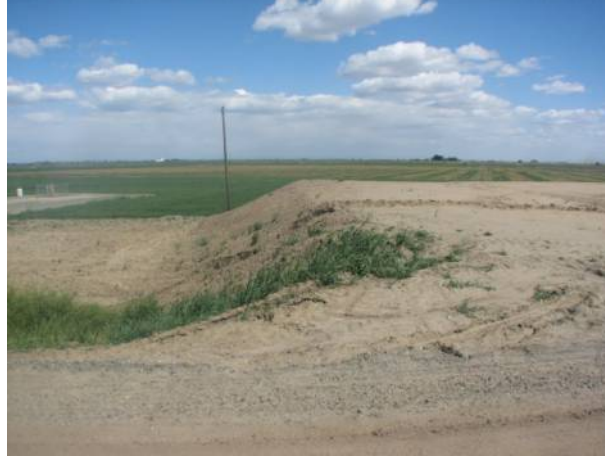
Levee Mile Report Line	31
Start Levee Mile	3.63
End Levee Mile	3.65
Location	Land Side
Category	Earthen Levee
Item	Encroachments

Looking east at left corner of house pad.

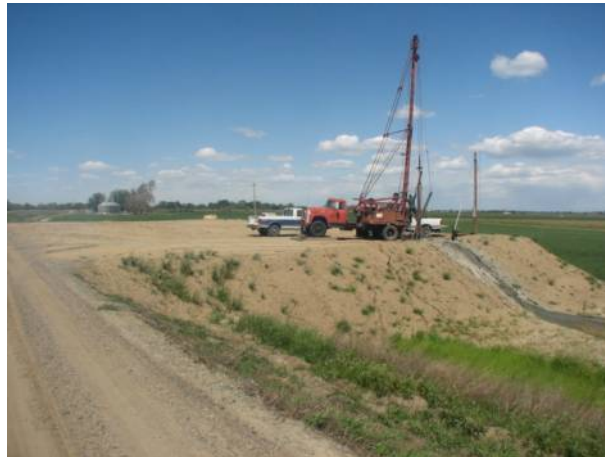
Levee Mile Report Line	31
Start Levee Mile	3.63
End Levee Mile	3.65
Location	Land Side
Category	Earthen Levee
Item	Encroachments

Looking downstream at house pad with utility pole and drilling rig on the landside of levee.

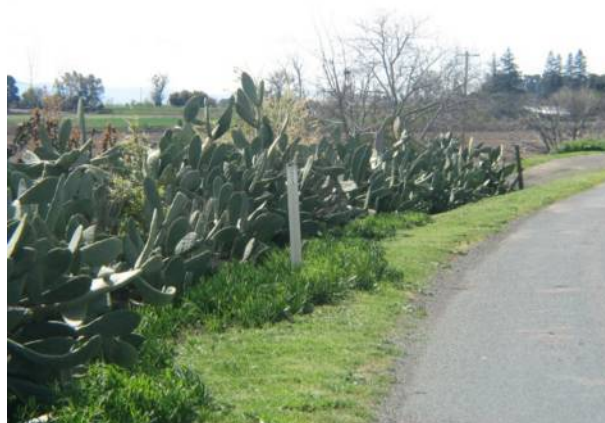
Levee Mile Report Line	38
Start Levee Mile	6.04
End Levee Mile	6.08
Location	Land Side
Category	Earthen Levee
Item	Vegetation

38	6.04	6.08	Earthen Levee	Vegetation	LS	U	Remove the wild growth other than native grasses from the levee slopes. Inspector Comments: Large Cactus on landward slope.	38.181965 ° -121.569913 °	38.181763 ° -121.570447 °	Y	22
39	6.06	6.40	Boat Survey	Boat Survey Erosion	LS	M	Inspector Comments: tree hazards, caves	38.182107 ° -121.570258 °	38.181487 ° -121.576143 °		928
40	6.11	6.38	Earthen Levee	Vegetation	WS	U	Remove the wild growth other than native grasses from the levee slopes.	38.181579 ° -121.571015 °	38.181279 ° -121.575739 °		942
41	6.13	6.13	Earthen Levee	Trim / Thin Trees	LS	M	Trim trees to at least five feet above ground level.	38.181498 ° -121.571325 °	38.181498 ° -121.571325 °		69
42	6.38	6.39	Earthen Levee	Trim / Thin Trees	LS	M	Trim trees to at least five feet above ground level.	38.181273 ° -121.575873 °	38.181217 ° -121.576070 °		23
43	6.42	6.44	Earthen Levee	Vegetation	LS	U	Remove the wild growth other than native grasses from the levee slopes.	38.181062 ° -121.576563 °	38.180977 ° -121.576803 °		24

Large Cactus plant on landward slope from LM 6.04 to 6.08

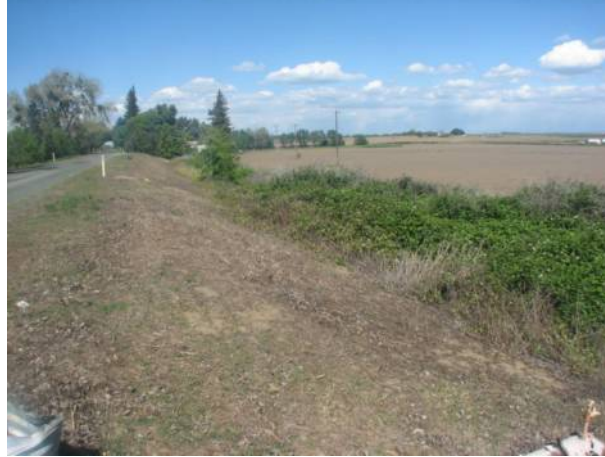
Levee Mile Report Line	47
Start Levee Mile	6.75
End Levee Mile	7.05
Location	Land Side
Category	Earthen Levee
Item	Vegetation

Side view of dense berryvines on landside toe.

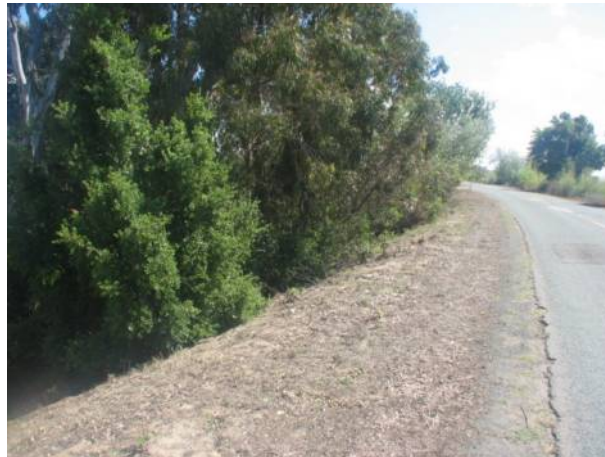
Levee Mile Report Line	49
Start Levee Mile	6.90
End Levee Mile	6.94
Location	Land Side
Category	Earthen Levee
Item	Trim / Thin Trees

Side view of dense trees along landside slope and shoulder.

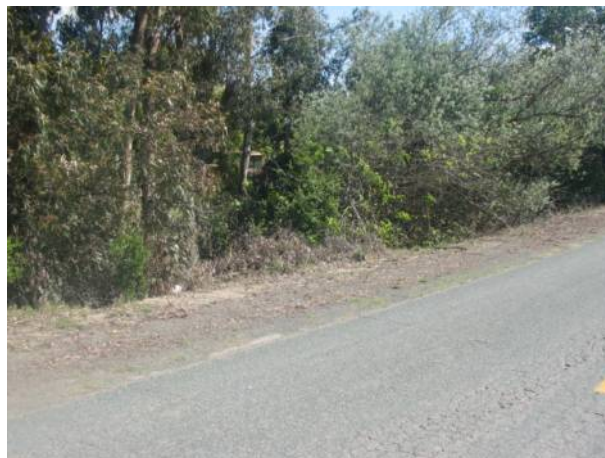
Levee Mile Report Line	49
Start Levee Mile	6.90
End Levee Mile	6.94
Location	Land Side
Category	Earthen Levee
Item	Trim / Thin Trees

Front view of dense trees along landside shoulder and slope.

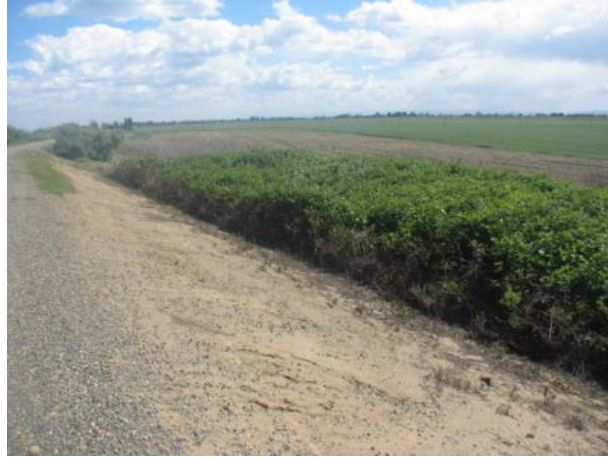
Levee Mile Report Line	67
Start Levee Mile	9.85
End Levee Mile	9.98
Location	Land Side
Category	Earthen Levee
Item	Vegetation
Looking downstream at dense wildroses at landside toe.

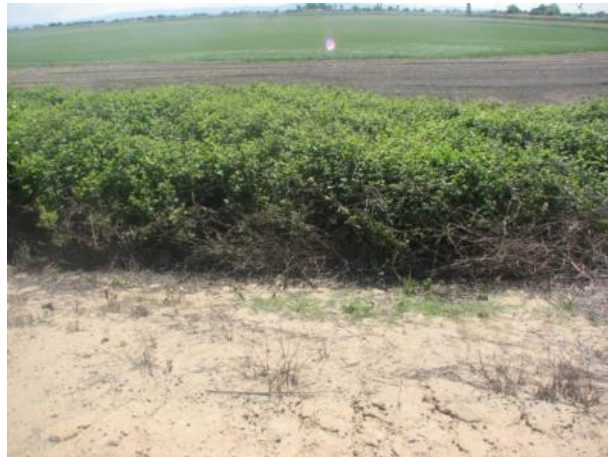
Levee Mile Report Line	67
Start Levee Mile	9.85
End Levee Mile	9.98
Location	Land Side
Category	Earthen Levee
Item	Vegetation
Front view of dense wildroses at landside toe.

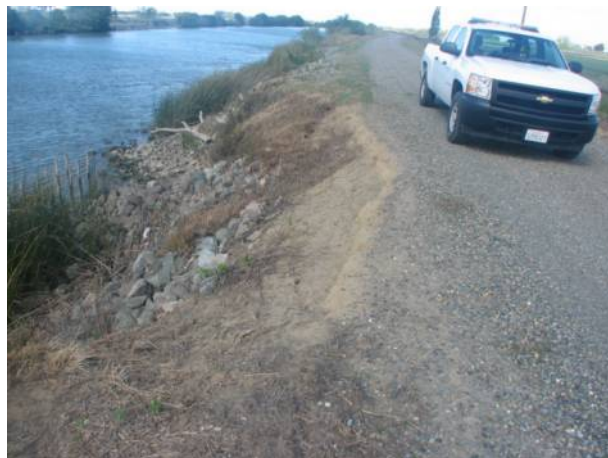
Levee Mile Report Line	73
Start Levee Mile	10.44
End Levee Mile	10.44
Location	Water Side
Category	Earthen Levee
Item	Erosion / Bank Caving
Looking downstream at erosion site on waterside slope and shoulder.

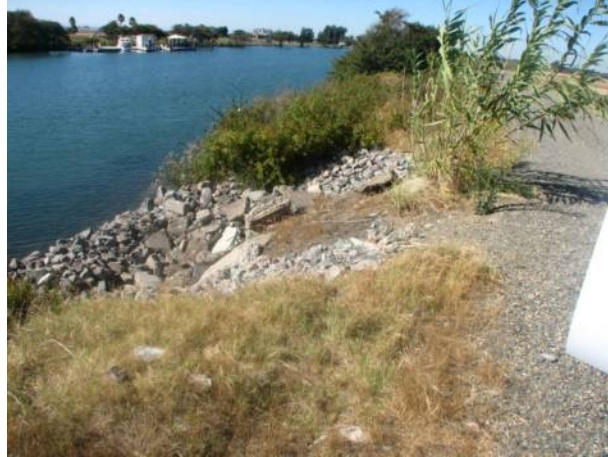
Levee Mile Report Line	76
Start Levee Mile	10.90
End Levee Mile	10.90
Location	Water Side
Category	Earthen Levee
Item	Slope Stability
Uncompleted slope stability repair on waterside slope.

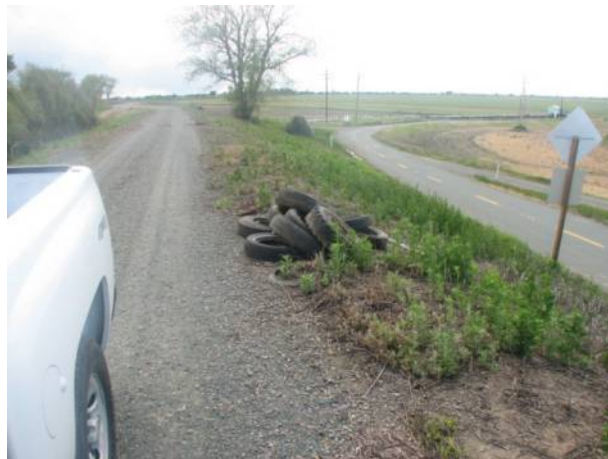
LMR Line	Levee Mile		Category	Item	Location	Rating	Action/Comment	GPS Latitude/Longitude		Photo	Issue
	Start	End						Start	End		
82	12.15	12.16	Earthen Levee	Encroachments	WS	M	Prunings	38.130766 ° -121.580528 °	38.130776 ° -121.580276 °		954
83	12.23	12.23	Earthen Levee	Trim / Thin Trees	LS	M	Trim trees to at least five feet above ground level.	38.130758 ° -121.579027 °	38.130758 ° -121.579027 °		47
84	12.26	12.26	Earthen Levee	Encroachments	LS	M	Garbage	38.130722 ° -121.578379 °	38.130722 ° -121.578379 °	Y	955

Levee Mile Report Line	84
Start Levee Mile	12.26
End Levee Mile	12.26
Location	Land Side
Category	Earthen Levee
Item	Encroachments
Rubber tires on landside shoulder.
